California Regional Water Quality Control Board
North Coast Region

Cleanup and Abatement Order No. R1-2004-0077

Windsor Oaks Associates LP

Enclosure 2 – Site Photos taken May 21, 2004 and June 14, 2004.

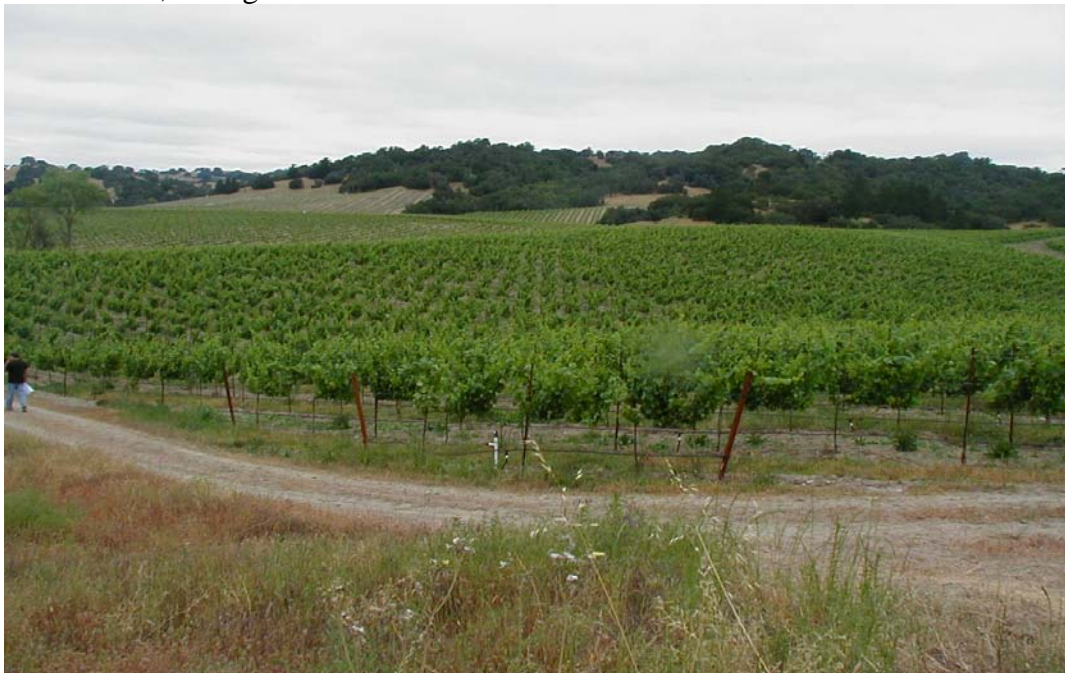
Culverted Stream Section - Field 8:

Field 8 is located up gradient of an existing reservoir. It appeared that an intermittent drainage feature had been culverted and filled during a vineyard conversion in 2001. The group reviewed aerial photographs of the area, and determined that a small water feature was present above the pond feature, and had been culverted and filled over to facilitate vineyard plantings (Photo 2).

Photo 2. View of intermittent drainage feature had been culverted and filled during a vineyard conversion in 2001, through Field 8. 5/21/04.

- a. A Workplan for removing the linear culverts and fill material from the intermittent tributaries that have been filled on the Site. The Workplan shall include information regarding the location and suitability of a chosen disposal site for the excavated fill material;

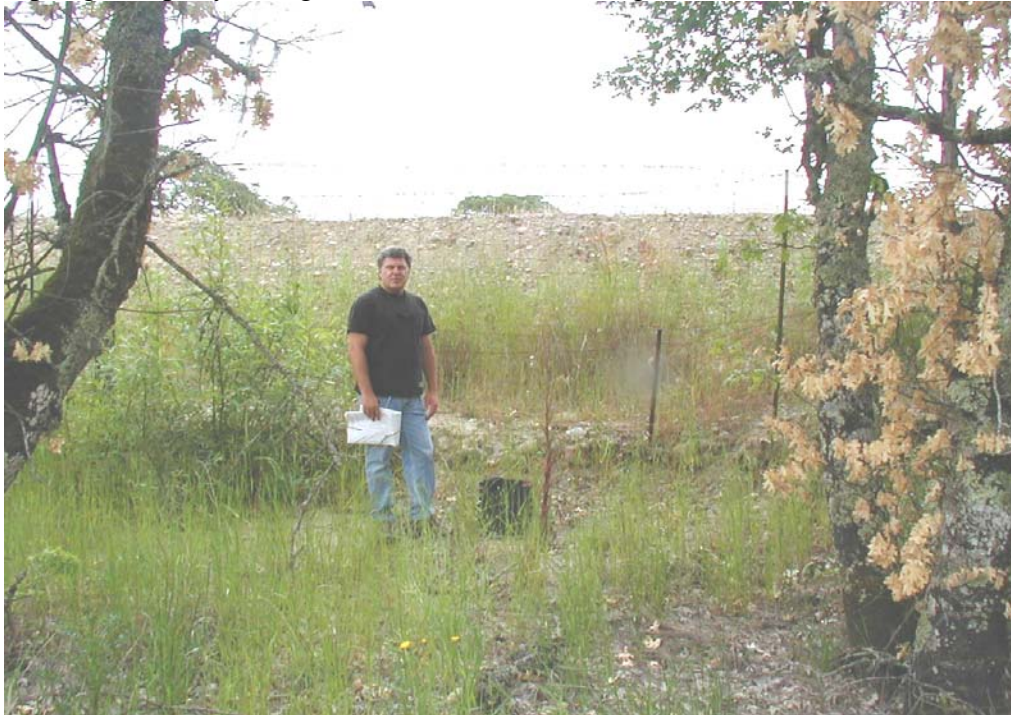
Wetland Impacts and Culverted Stream Section (Starr Creek T-3)– Field 6:

Mr. Martel of the ACOE determined that there was a wetland feature at the base of Field 6 that had been impacted by the vineyard conversion performed sometime between 2001 and 2003. Mr. Martel identified another wetland area below the road and Field 6, which has been impacted by the installation of culverts. In addition, the Discharger gave permission to the adjacent property owner, Mr. Rich Carnation and Brookfield Investors, LLC, to extend a culvert from the Diamond Springs Property onto the Site, to capture flow of Starr Creek T-3, which was culverted through Field 6, as described below, and subsequently through the Diamond Springs Property. In addition, at the top of Field 6 an intermittent tributary of Starr Creek, identified as Starr Creek Tributary #3 (T-3) on the improvement plans prepared by Kenneth Carr and Associates dated November 17, 2002, had been culverted and filled to facilitate the planting of the vineyard unit. Mr. Martel also determined that an ordinary high water channel was evident above Field 6, which was culverted and filled through Field 6. Another small intermittent tributary appears to have been filled directly to the west of T-3. The Discharger did not obtain any resource agency approvals for the culverting and filling of the intermittent tributary or to impact the wetland habitat. Staff requested copies of pre-project and post-project aerial photographs from the Discharger to help determine the extent of impacts (Photo 4-5).

Photo 4. View of a culvert that has been installed in a designated wetland area on the Site. Diamond Springs Property filling activities shown in background. 5/21/04.

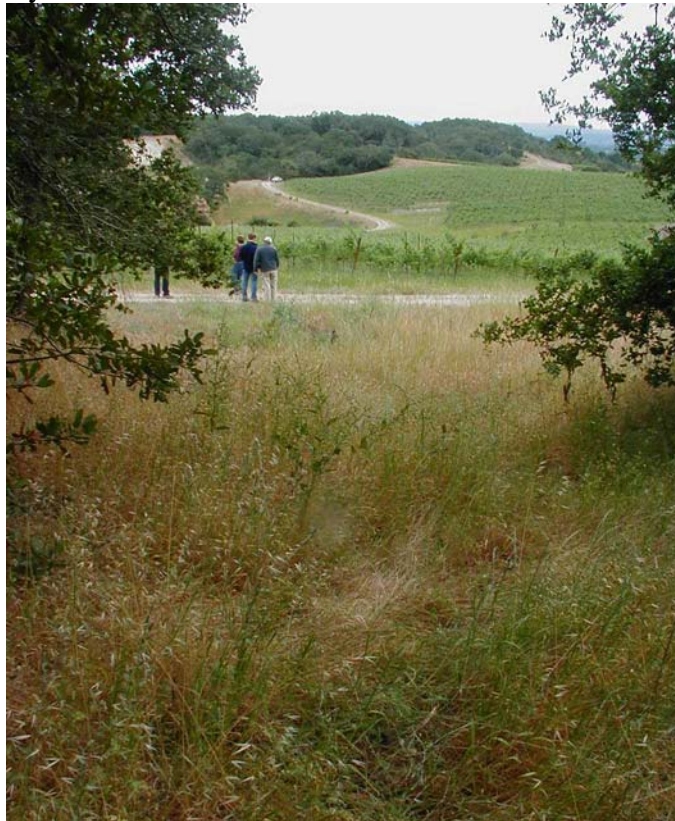
Photo 5. View of intermittent tributary, facing downstream, that has been culverted and filled through the Field 6 vineyard unit. 5/21/04

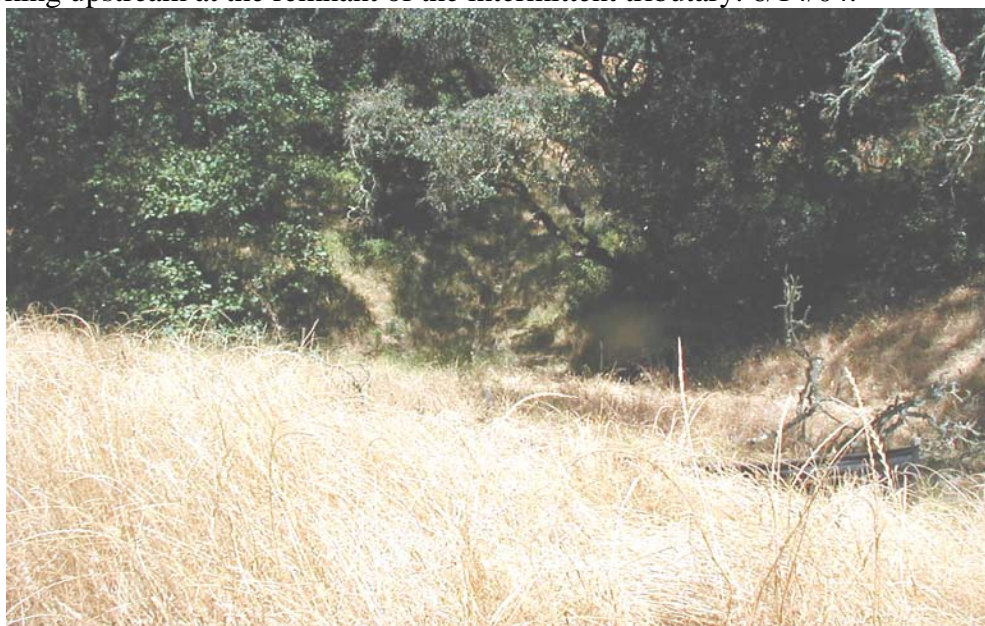
Culverted Stream Section Field 7:

The ACOE determined an intermittent tributary of Starr Creek T-8 to be Waters of the U.S. during the site inspection. The small intermittent tributary has a defined channel above Field 7, but has been culverted and filled with a 20-foot fill prism, through Field 7 to facilitate vineyard development. Above Field 7 the intermittent tributary has a well-established riparian zone and appears to provide some high quality habitat. Below Field 7, the culverted tributary daylights and flows into Starr Creek T-8. Staff requested copies of pre-project and post-project aerial photographs from the Discharger to help determine the extent of impacts (Photos 6-7).

Photo 6. View of intermittent tributary of Starr Creek T-8 that had been culverted and filled with a 20+-foot fill prism, through Field 7, to facilitate a vineyard conversion. View from the fill prism, looking upstream at the remnant of the intermittent tributary. 6/14/04.
